DEPARTMENT OF TRANSPORTATION

Contract #: 04-0120F4Cty: SF/ALA Rte: 80 PM: 13.2/13.9File #: 69.28**WELDING INSPECTION REPORT****Resident Engineer:** Pursell, Gary**Address:** 333 Burma Road**City:** Oakland, CA 94607**Report No:** WIR-012060**Date Inspected:** 30-Jan-2010**Project Name:** SAS Superstructure**OSM Arrival Time:** 700**Prime Contractor:** American Bridge/Fluor Enterprises, a JV**OSM Departure Time:** 1900**Contractor:** Zhenhua Port Machinery Company, Ltd (ZPMC), Changxing Island **Location:** Shanghai, China

NORTH TOWER LIFT 4 C/D CORNER REPAIR (T-CWR533 REV. 1)

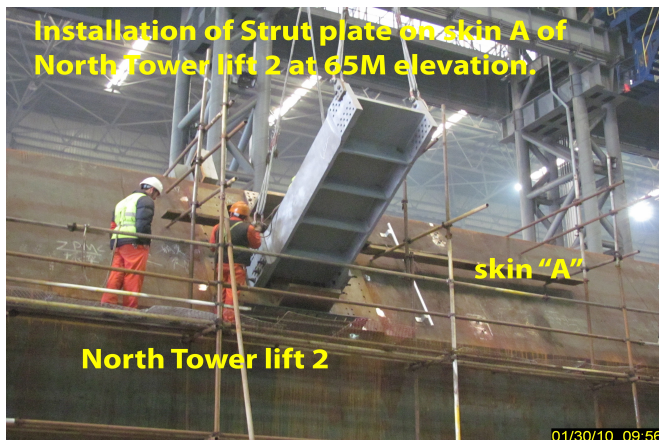
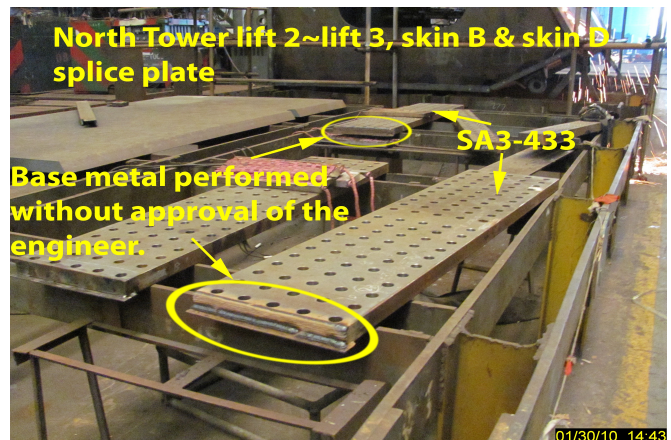
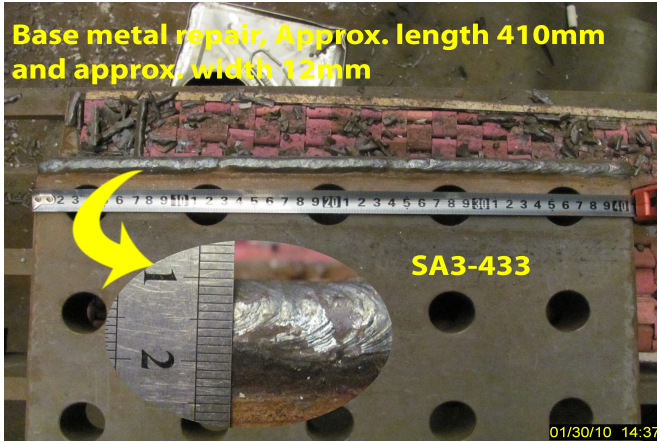
During random in process verification, this QA Inspector observed the installation of Strut plate on skin A of North Tower lift 2 at 65M elevation level. Attached photographs provide additional details.

During random in-process observations of the fabrication of North Tower lift2 ~ lift 3, skin B & skin D splice plates, this Quality Assurance (QA) inspector observed the deposition of weld metal (buttering/build up) by Shielded Metal Arc Welding (SMAW) process on the base metal edge of splice plates for skin B and skin D of North Tower lift 2 ~ lift 3. This base metal repair was performed without the approval of the Engineer. This build up was performed across the entire width of the edge and measured approximately 12mm thick and approximately 410mm in length. The material thickness is 50mm. The members are both identified as SA3-433. The members are located in Tower Bay 10.

The attached photographs provide additional detail.
